UNDOING A MIRACLE CURE-ALL
REMOVING AN ACRYLIC COATING FROM FEDERAL HALL NATIONAL MEMORIAL

Walter Sedovic, AIA

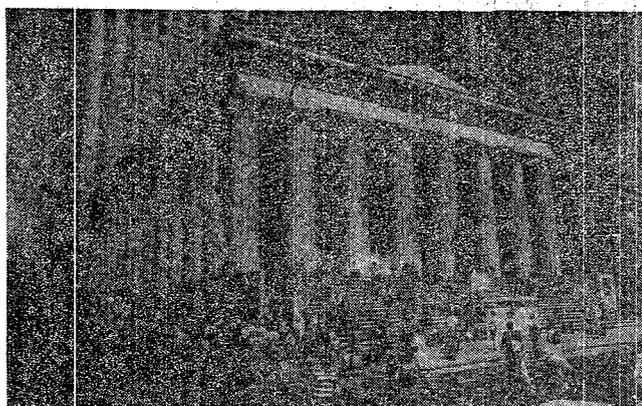
The Hydron was applied in mid-summer. Within a few months something unexpected began to happen: Federal Hall's golden white marble facades began to turn a dull, ashen grey. Worse, the darkening tended to be more pronounced where the coating was thicker, so that every drip mark and overlap from the spraying was highlighted. It had become obvious, the project completion report continued, "that the treated area was attracting dirt more rapidly than the untreated area."² Believing that the coating had been faultily applied, the project supervisors ordered the accumulated surface dirt washed off, and the building was sprayed, at no additional cost, with a second coat of Hydron. But Federal Hall began again to turn grey, growing progressively darker over the next fifteen years until, in 1986, the coating was removed.

Figure 1. Federal Hall National Memorial, prior to coating removal, June 1986.

In 1986, the National Park Service concluded that the only way to reverse the darkening effect of the Hydron and to restore Federal Hall's marble facades to their natural golden white color was to remove the coating. To do so required first analyzing the coating to gain a thorough understanding of its properties and intended use and then testing a range of methods to select an appropriate removal technique. That the entire building had been spray coated with Hydron, not once but twice, increased the challenge.

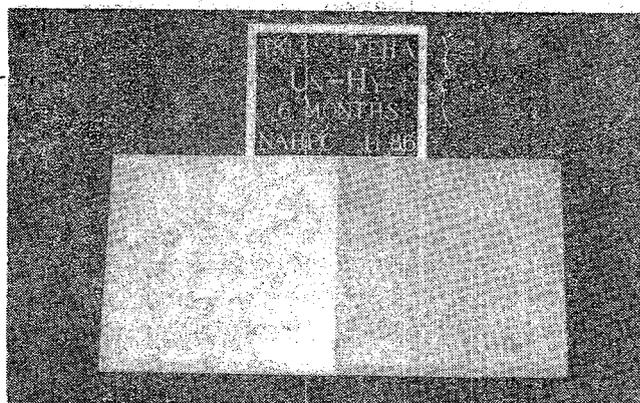
thought, the coating's waterproofing characteristics would be useful. Unfortunately what was not foreseen was that the very properties that make Hydron graffiti-resistant make it unsuitable as an all-over coating on a building in a densely populated urban area: a surface that attracts moisture will also attract moisture-borne pollutants and dirt. The unsettling results of the 1971 application of Hydron to Federal Hall were exhibited again on a weathering test panel installed on the building's roof in 1986, demonstrating how remarkably fast this effect can happen (Fig. 2).

Figure 2. Weathering test panel on the roof of Federal Hall, November 1986. The right half of panel was coated with Hydron in May 1986, the left was left uncoated.

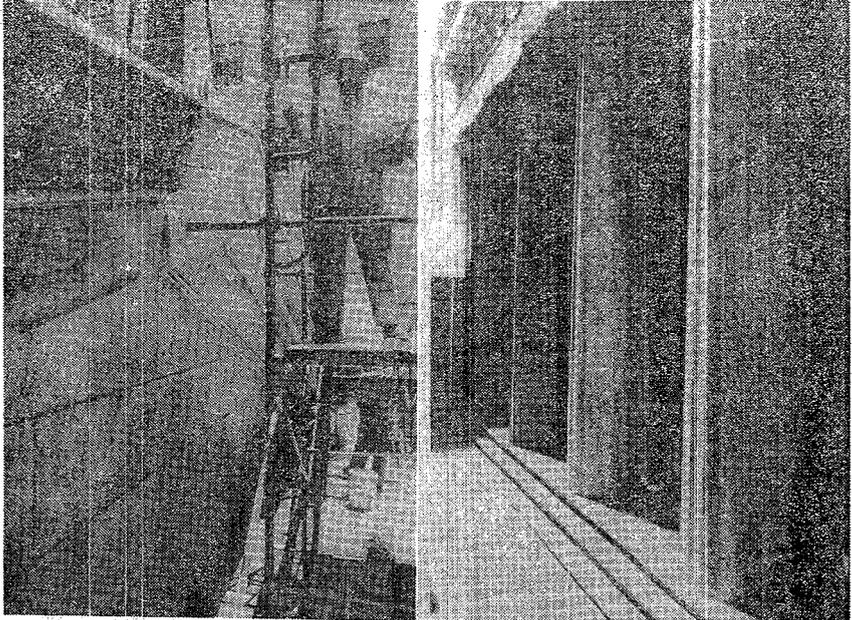
Figure 7. Cleaning Federal Hall's cornice with alkaline solution, June 1986. Figure 8. Two cleaned columns on north portico, June 1986.

We resumed testing, trying next a treatment somewhat harsher than we had anticipated would be necessary. A highly alkaline proprietary solution containing primarily potassium hydroxide worked well when followed by a water wash at 400 to 600 psi. This solution worked not only on the test panels but on the more stubborn coating on the building's surfaces. It too had its drawbacks, however. There was the potential danger of overcleaning if left on the surfaces too long, or of reacting with iron compounds in the marble and leaving brown ferrous hydroxide stains, thus affecting the subtle golden hues of the marble along with the Hydron. To minimize the danger, we experimented with dwell times and determined that 15 minutes was optimal and that leaving the solution on the marble for up to 45 minutes still posed no serious threat. The possible effect of the acid wash required to neutralize the alkali solution was another concern. The dolomitic marbles on Federal Hall are naturally resistant to relatively weak acid solutions, and the dilute acetic acid specified for the wash caused no harm. Nevertheless, it was further decided that all building surfaces and the final rinse water should be

continuously pH-monitored throughout the cleaning process. Having assured ourselves as to its effectiveness and safety, we chose the potassium chloride solution as the optimal treatment.

The acrylic coating has been removed from two sides of Federal Hall, and the work is to continue in 1987 (Figs. 7,8). The newly cleaned facades, which still retain the beauty of the stone's natural patina of age, attest to the success of the project.
